(21) Report on
OPERATION UPHOT-KNOTHOLE,

Project 3.20(12)

(6) BLAST AND THERMAL EFFECTS
OF AN ATOMIC BOMB ON TYPICAL
TACTICAL COMMUNICATION SYSTEMS (17) (8)

(10) by Jacob Eggert and
Elmer R. Higgins

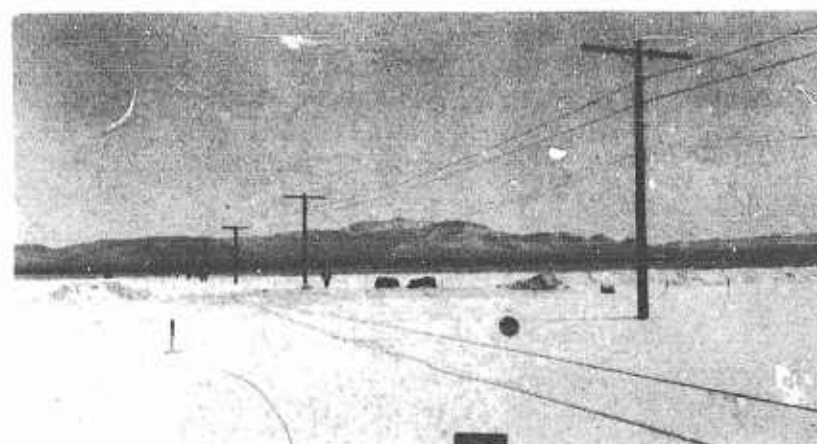
Fig. 3.5 Shots 9 and 10, Test Groups 1 and 1A, Radial Pole Line, Poles L-1 through D-10. D-10 in Foreground.
 (Top-before 9, Center-after 9, Bottom-after 10)
 Shot 9 - 9080-7550 ft, 8-13 cal, 3-3.6 psi.
 Shot 10 - 8350-6950 ft, 5.5-8.5 cal, 1-1 psi.

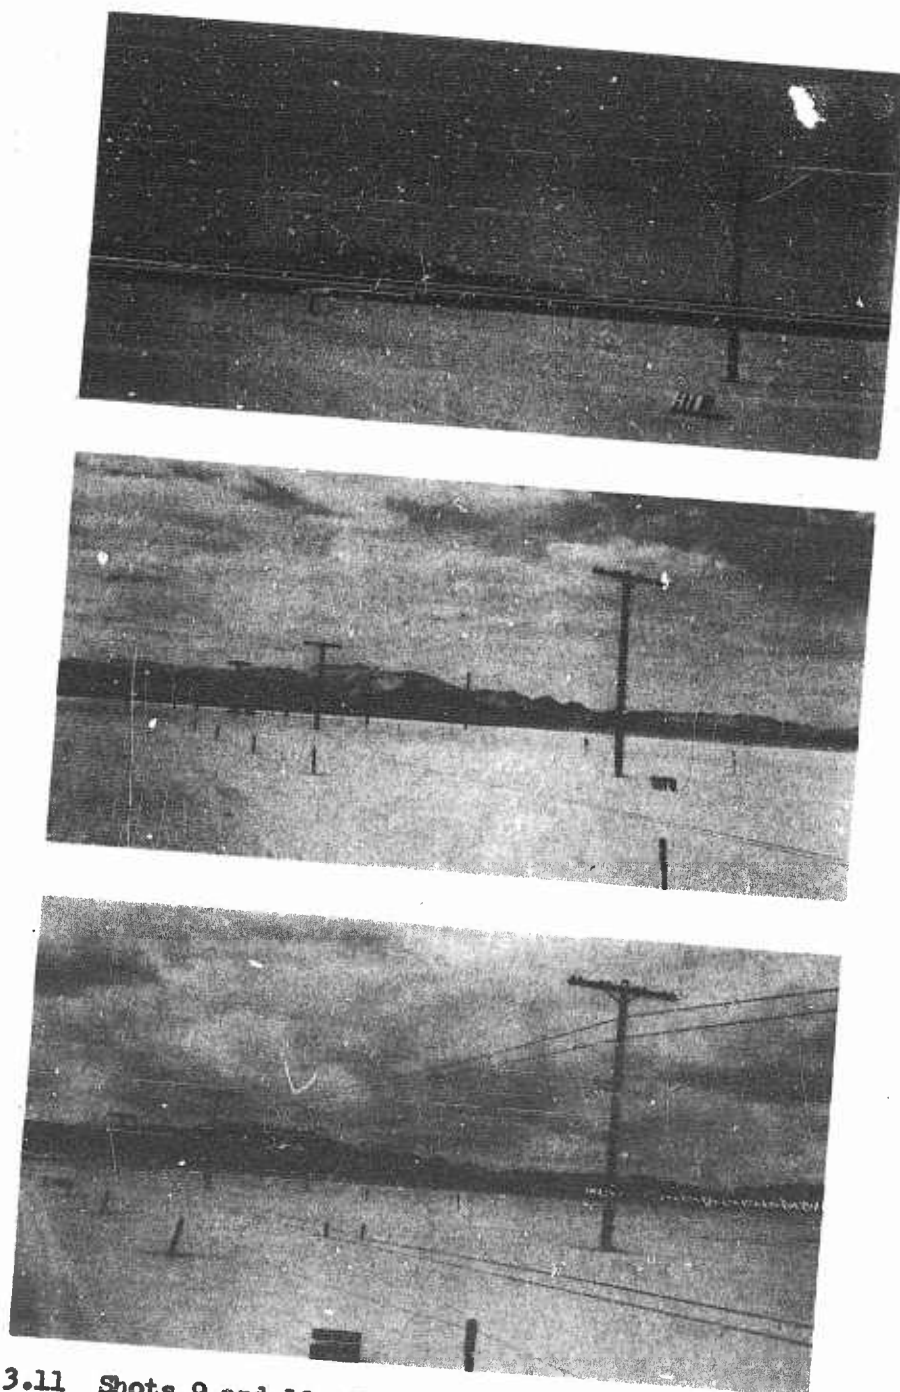
Fig. 3.11 Shots 9 and 10, Test Groups 1 and 1A, Radial Pole Line, Poles D-1 through D-26. D-26 in Foreground. (Top-before 9, Center-after 9, Bottom-after 10)
 Shot 9 - 9080-5150 ft, 8-27.5 cal, 3-5.8 psi.
 Shot 10 - 8350-4500 ft, 5.5-21 cal, 1-4 psi.

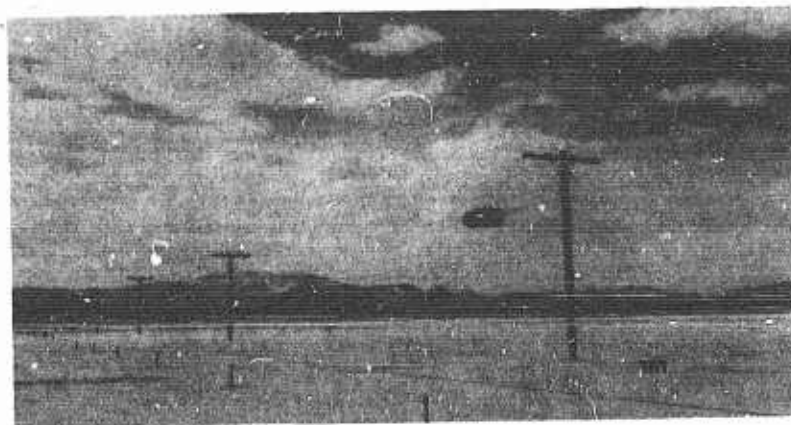
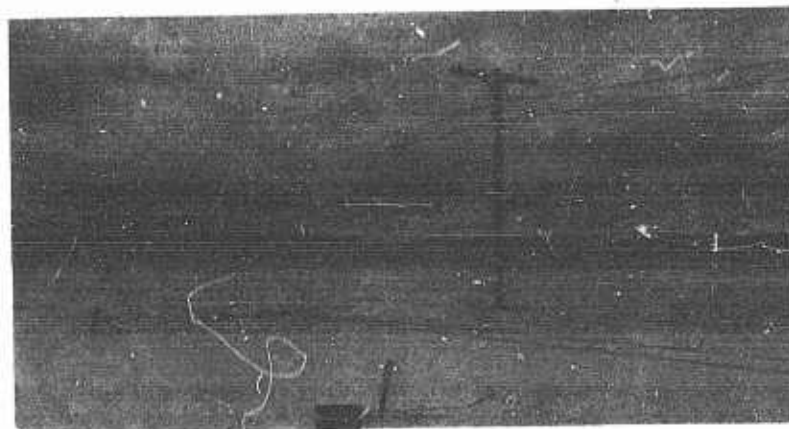
Fig. 3.12 Shots 9 and 10, Test Groups 1 and 1A, Radial Pole Line, Poles D-25 through D-28. D-28 in Foreground.
 (Top-before 9, Center-after 9, Bottom-after 10)
 Shot 9 - 5280-4750 ft, 26.5-31 cal, 5.7-6.6 psi.
 Shot 10 - 4670-4150 ft, 20.5-24.5 cal, 4-4 psi.

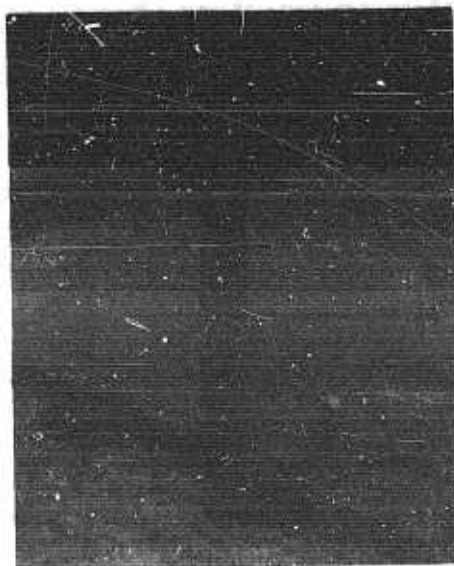
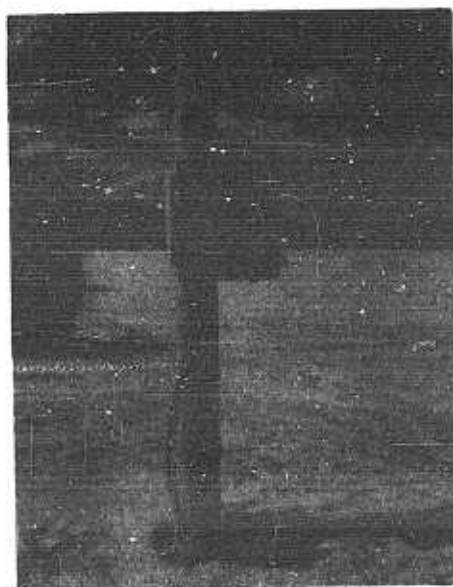
Fig. 3.15 Shot 9, Test Group 1, Radial Pole Line, Cable Transfer Relay on Pole D-35. (Top-before, Bottom-after) 3750 ft, 44.5 cal, 8.8 psi.

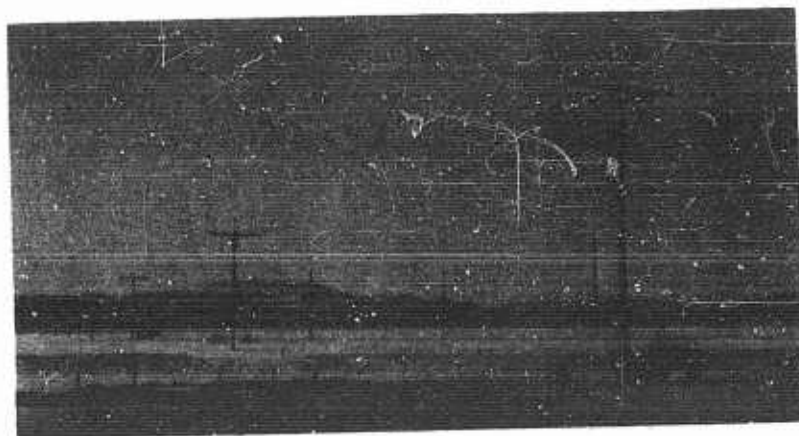
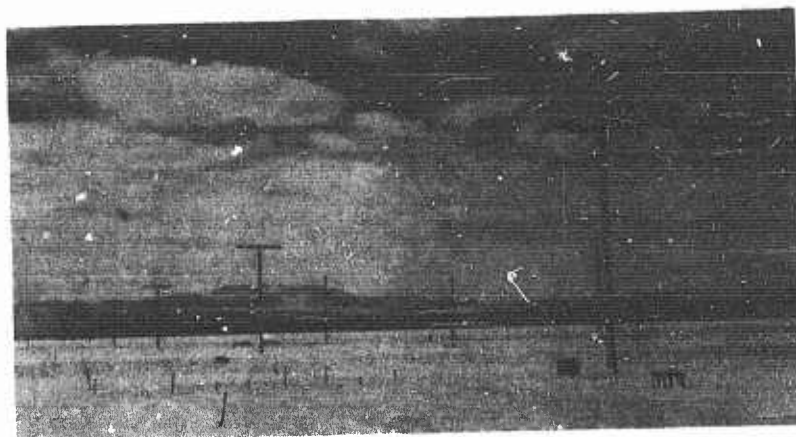
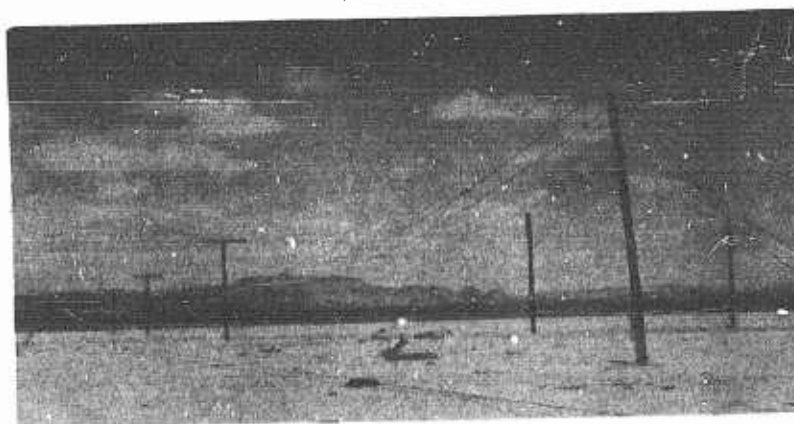
Fig. 3.16 Shots 9 and 10, Test Groups 1 and 1A, Radial Pole Line
 (Top-before 9, Poles D-1 through D-37; Center-after 9, Poles
 D-1 through 37; Bottom-after 10, Poles D-1 through D-36)
 (D-37 through D-52 Not Shown in this Photo were Destroyed in
 Shot 10) Shot 9 - 9080-3500 ft, 8-49 cal, 3-9.4 psi.
 Shot 10 - 8350-2900 ft, 5.5-47.5 cal, 1-5 psi.

b. RESULTS: The pole line as a whole received severe damage from pole D-52 (600 ft, over 65 cal, over 115 psi), out to and including pole D-37 (2900 ft, 47.5 cal, 5.0 psi). In this section of the line 16

poles were splintered at the base of the poles, broken or disintegrated into one or more pieces and blown about the area along the pole line. There was a miscellaneous conglomeration of crossarms, pins, insulators, open wire, lead covered cable, rubber covered cable, spiral four cable, and field wire snarled together along this section of the pole line. The degree of severe damage stopped abruptly at pole D-36. Damage summaries are shown in Table 3.4.

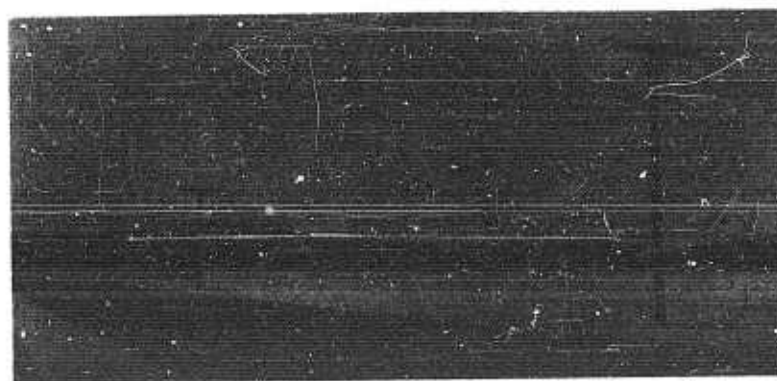
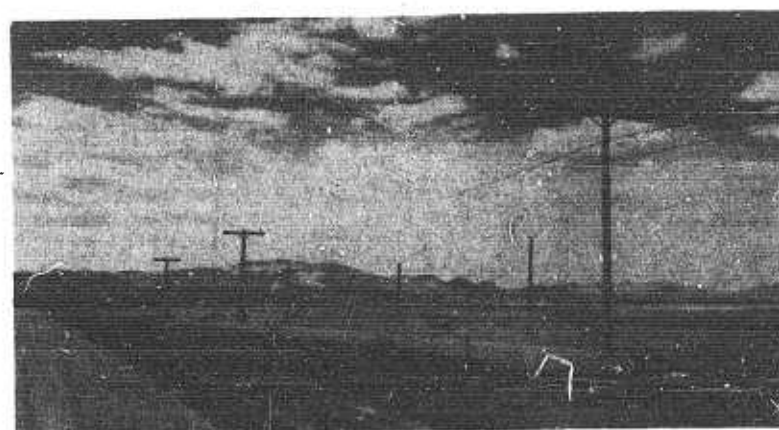
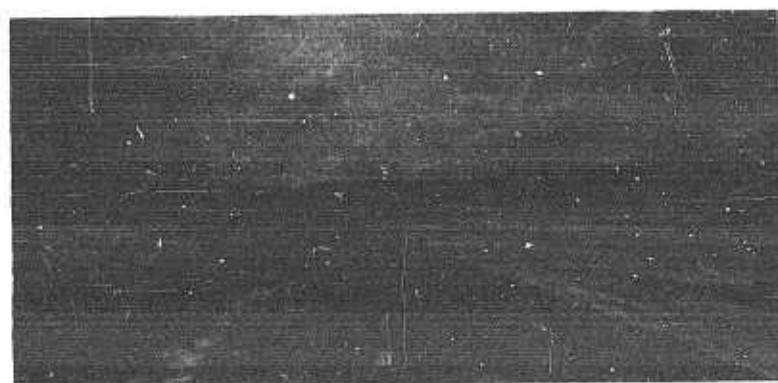
Fig. 3.19 Shots 9 and 10, Test Groups 1 and 1A, Radial Pole Line, Poles D-1 through D-44. D-44 in Foreground in Top and Center Views. In Bottom View Poles D-37 through D-52 have been destroyed in Shot 10. (Top-before 9, Center-after 9, Bottom-after 10)
 Shot 9 - 9080-2450 ft, 8-69 cal, 3-11.2 psi.
 Shot 10 - 8350-1820 ft, 5- over 65 cal, 1-9 psi.

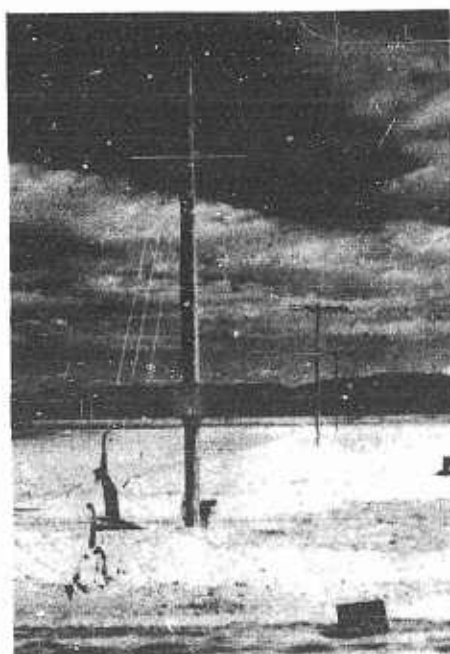
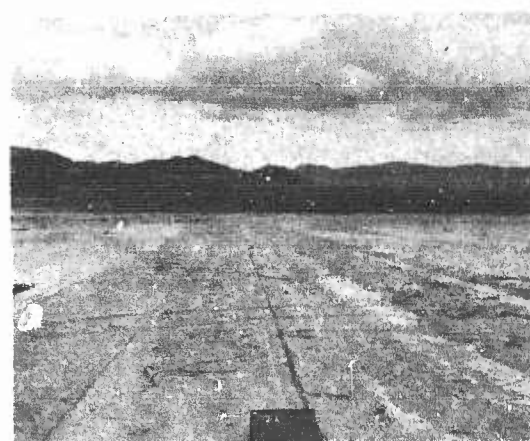
Fig. 3.22 Shots 9 and 10, Test Groups 1 and 1A, Radial Pole Line, Poles D-52 through D-50 in Top View, D-52 in Foreground; Poles D-52 through D-1 in Bottom Left View, D-52 in Foreground; Poles D-52 through D-36 Bottom Right View Destroyed in Shot 10. (Top-before 9, Bottom Left-after 9, Bottom Right-after 10)
 Shot 9 - 1550-1250 ft, 98-113 cal, 14.16.6 psi.
 Shot 10 - 2250-600 ft, over 65 cal, 7.0-over 115 psi.

(2) CROSSARMS: All crossarms received slight surface charring on the GZ faces but damage was negligible. The outside crossarm of double crossarm on the dead end pole closest to GZ (pole D-52 at 1250 ft; 113 cal, 16.6 psi) was slightly twisted. All crossarms were serviceable after the shot.

(4) GLASS INSULATORS: All insulators on the outside crossarms on the dead end pole (pole D-52 at 1250 ft; 113 cal, 16.6 psi) were broken. There were two broken insulators on pole D-51 at 1400 ft; 103 cal, 15.4 psi. In all cases where there were broken insulators the open wire remained attached to the insulator and pin. All other insulators were serviceable after the shot.

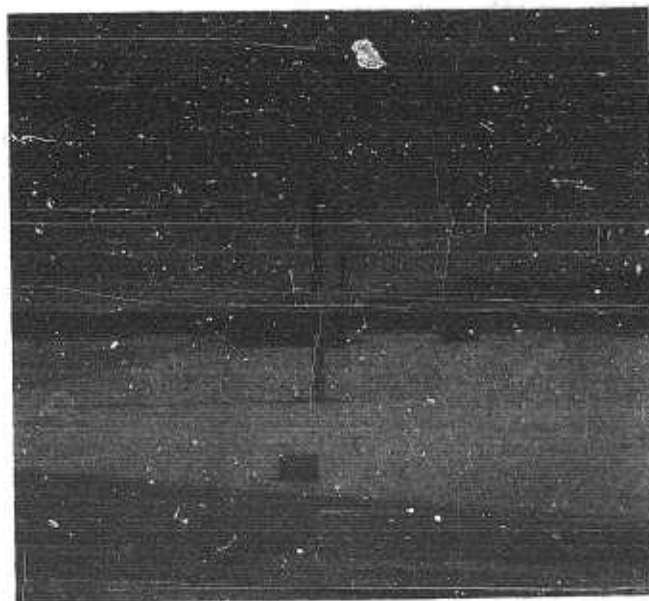
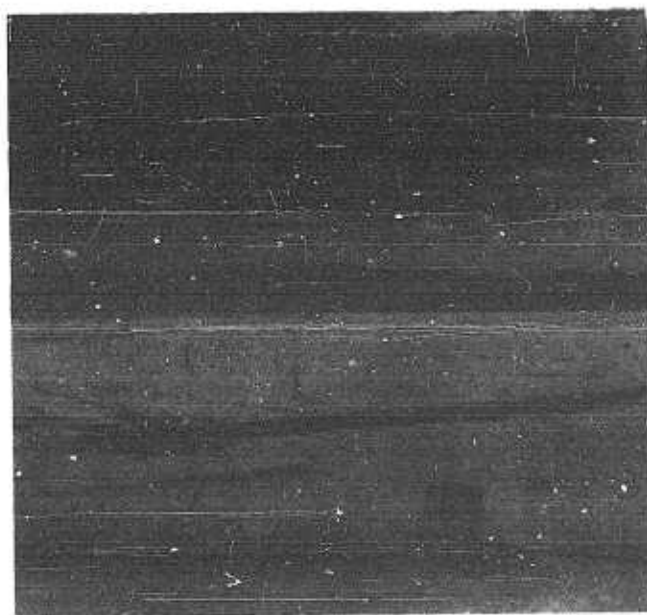
Fig. 3.27 Shot 9, Test Group 24, Transverse Pole Line, Poles C-1 through C-2, C-2 in Foreground. (Top-before, Bottom-after) 3425 ft, 50 cal, 9.6 psi.

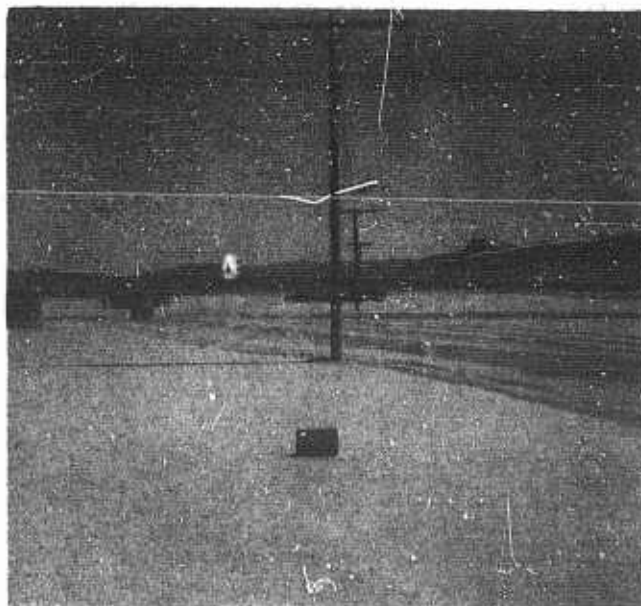
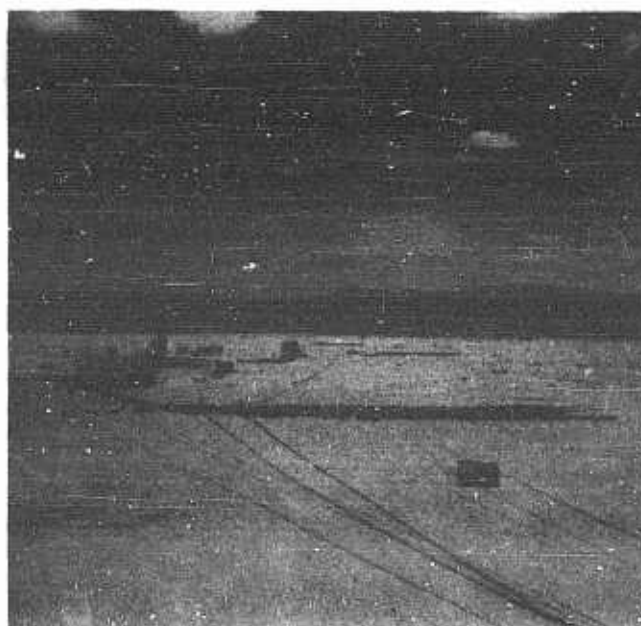
Fig. 3.28 Shot 9, Test Group 24, Transverse Pole Line, Poles C-1 through C-3, C-3 in Foreground. (Top-before, Bottom-after) 3425 ft, 50 cal, 9.6 psi.

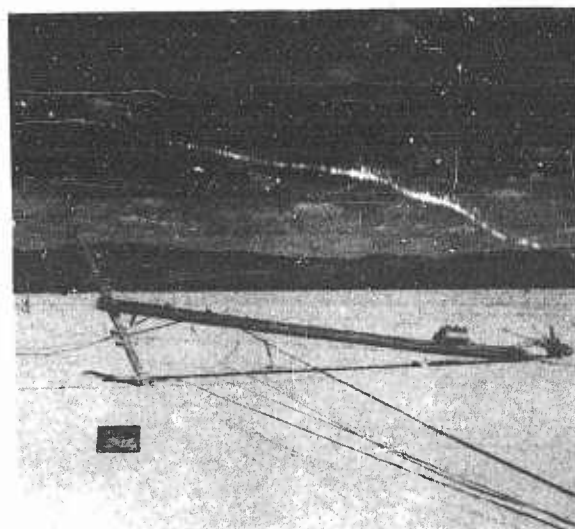
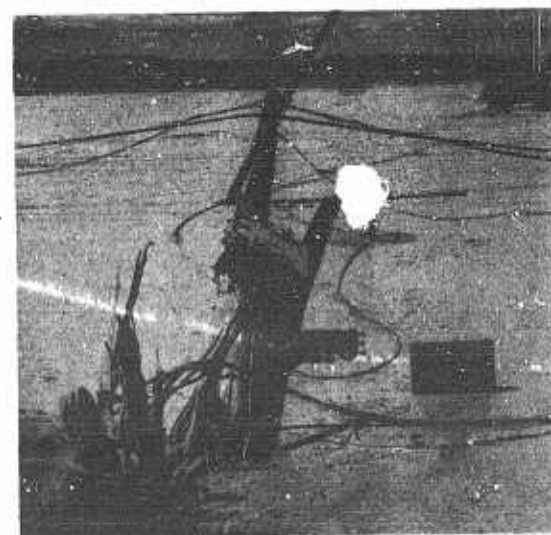
Fig. 3.29 Shot 9, Test Group 24, Transverse Pole Line, Poles C-1 through C-4, C-4 in Foreground. (Top left-before, Bottom left-after, Top right-before, Bottom left-after) Close-ups of Cable Transfer Relay on Pole C-4 (Right). 3425 ft, 50 cal, 9.6 psi.

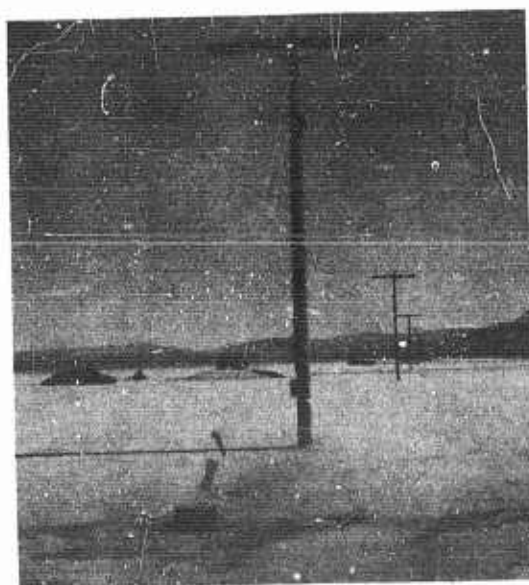
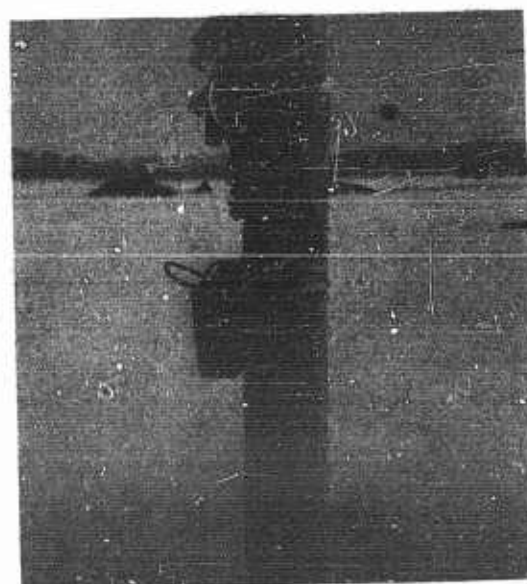
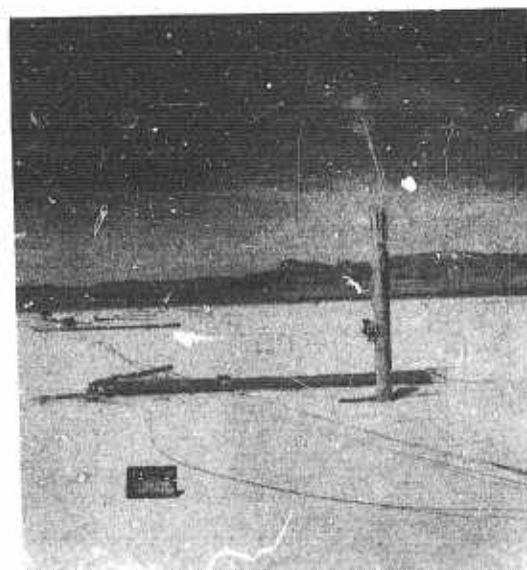
Fig. 3.33 Shot 9, Test Group 24, Transverse Pole Line, Poles C-1 through C-8, C-8 in Foreground. Right Shows Close-ups of EE-8 Telephone and TM-184 Terminal Strip on Shielded Side of Pole C-8. (Top left-before, Bottom left-after, Top right-before, Bottom right-after) 3425 ft, 50 cal, 9.6 psi.

(13) FIELD TELEPHONES: The field telephones on poles C-1 and C-8 were shielded from the thermal flux and received no significant thermal or blast damage.

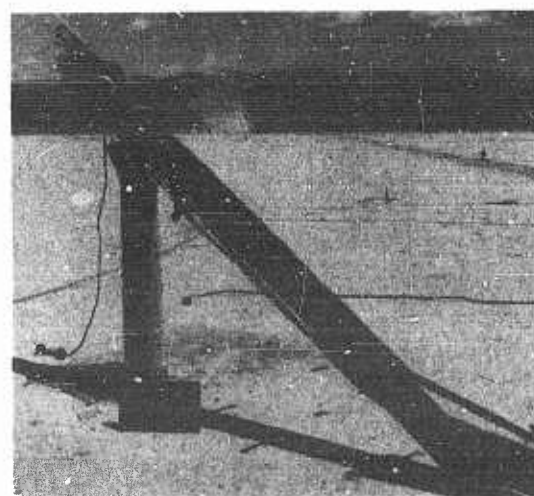
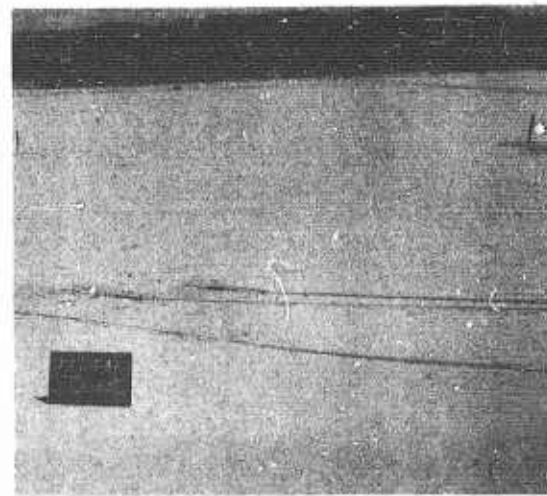
Fig. 3.35 Shot 9, Test Group 27, Transverse Pole Line,
Close-up of Pole B-1. (Top-before, Bottom-after)
4450 ft, 35 cal, 7 psi. Right - Close-ups of Triple
guys on Pole B-1. (Top-before, Bottom-after)

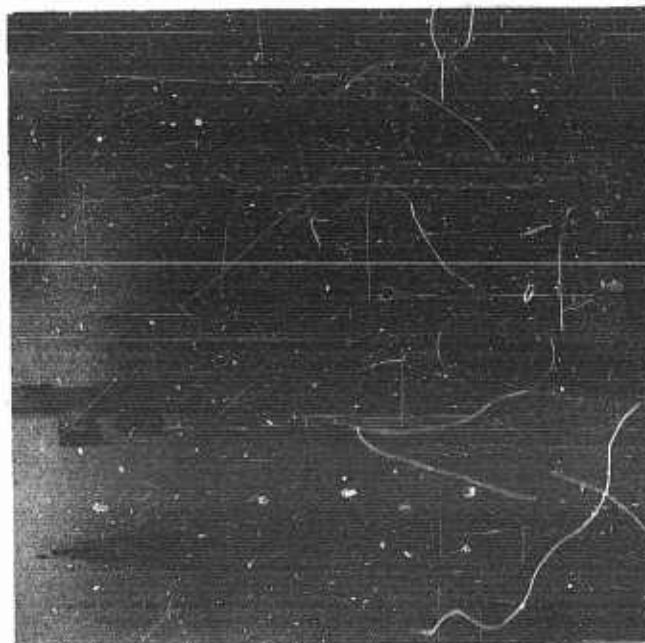
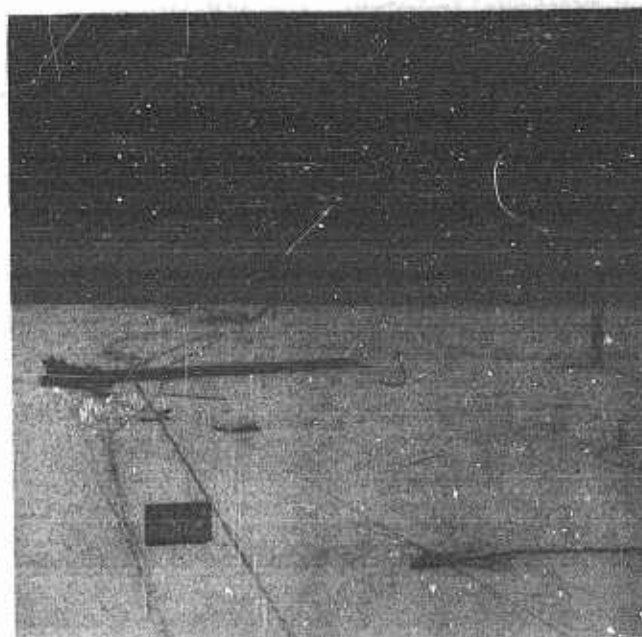
Fig. 3.36 Shot 9, Test Group 27, Transverse Pole Line, Poles B-1 through B-2, B-2 in Foreground. (Top-before, Bottom-after) 4450 ft, 35 cal, 7 psi.

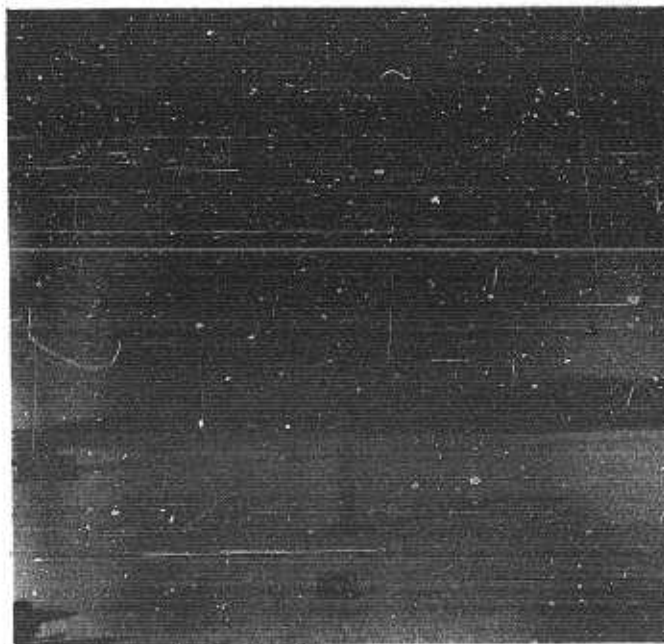
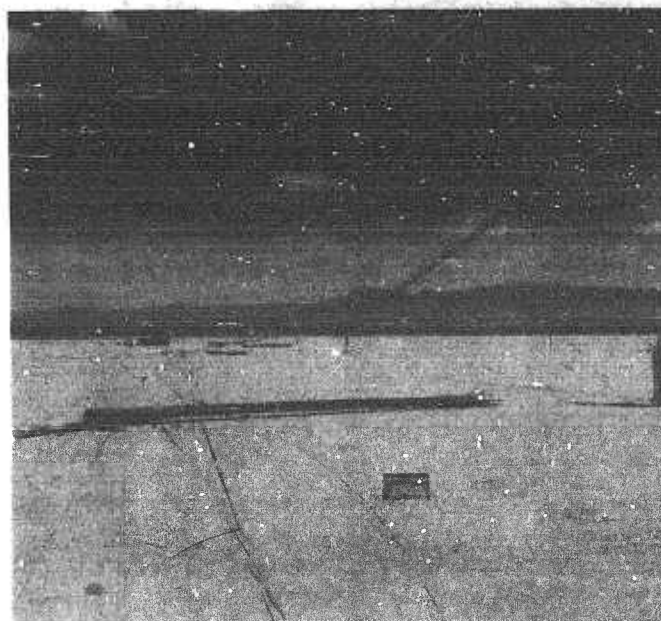
Fig. 3.39 Shot 9, Test Group 27, Transverse Pole Line, Poles B-1 through B-5, B-5 in Foreground. (Top-before, Bottom-after) 4450 ft, 35 cal, 7 psi.

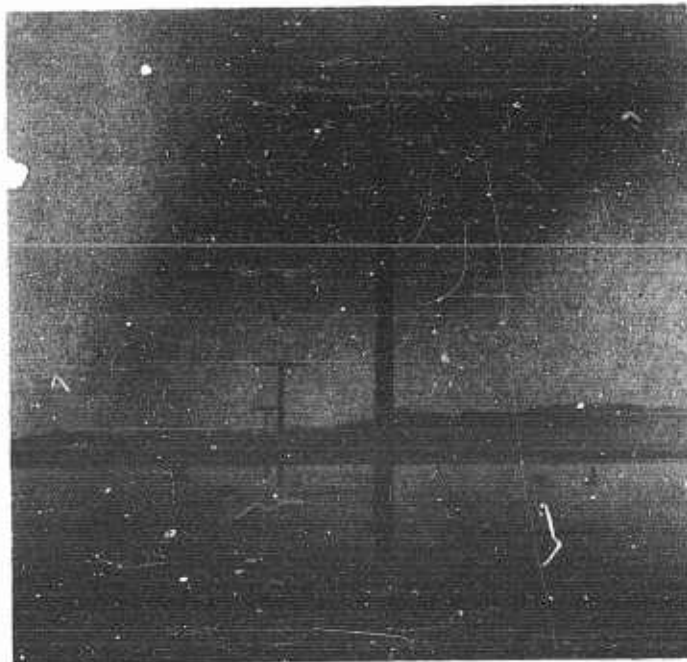
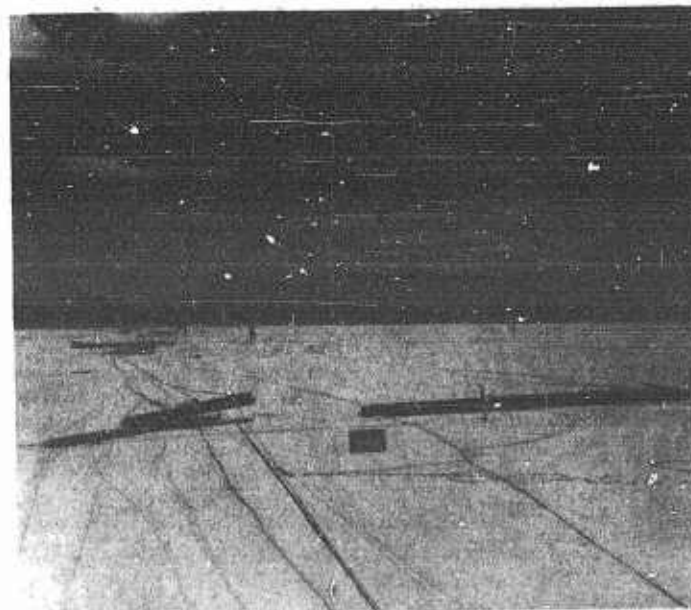
Fig. 3.37 Shot 9, Test Group 27, Transverse Pole Line, Poles B-1 through B-3, B-3 in Foreground. (Top-before, Bottom-after) 4450 ft, 35 cal, 7 psi.

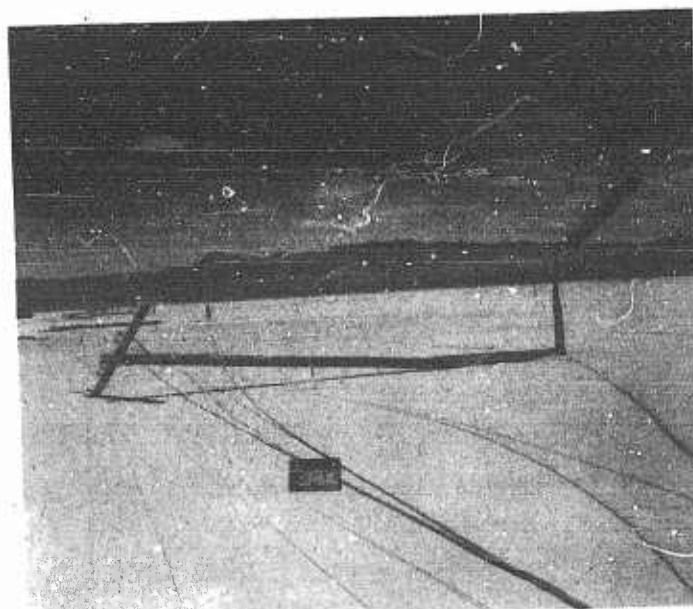
Fig. 3.40 Shot 9, Test Group 27, Transverse Pole Line, Poles B-1 through B-6, B-6 in Foreground. (Top-before, Bottom-after) 4450 ft, 35 cal, 7 psi.

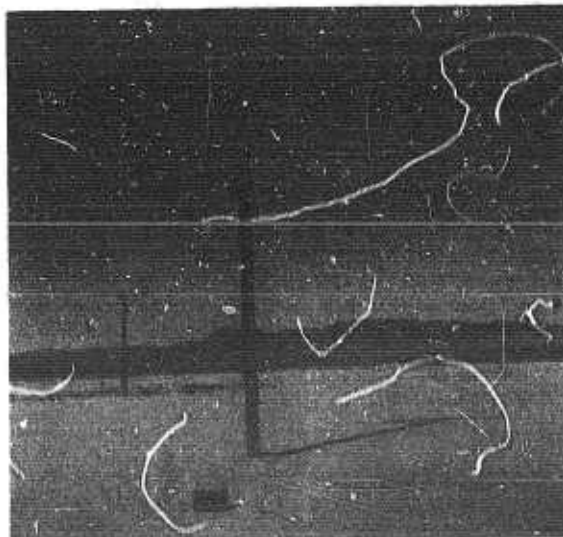
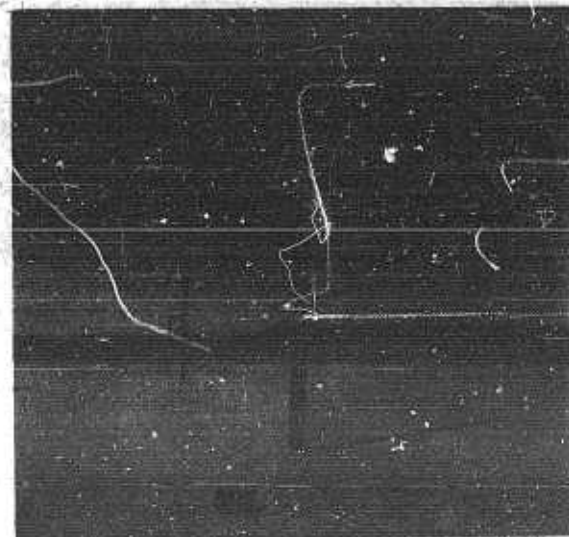
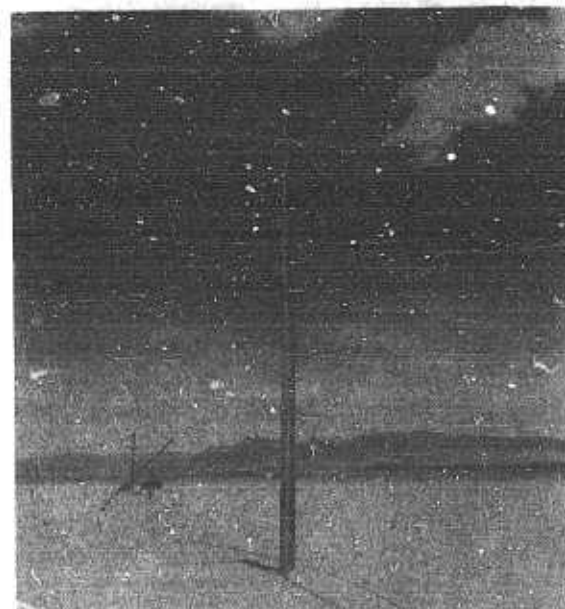
Fig. 3.45 Shot 9, Test Group 30,
Transverse Pole Line, Poles A-1
through A-2, A-2 in Foreground.
(Top-before, Bottom-after) 5425 ft,
25.5 cal, 5.6 psi.

Fig. 3.46 Shot 9, Test Group 30,
Transverse Pole Line, Poles A-1
through A-3, A-3 in Foreground.
(Top-before, Bottom-after) 5425 ft,
25.5 cal, 5.6 psi.

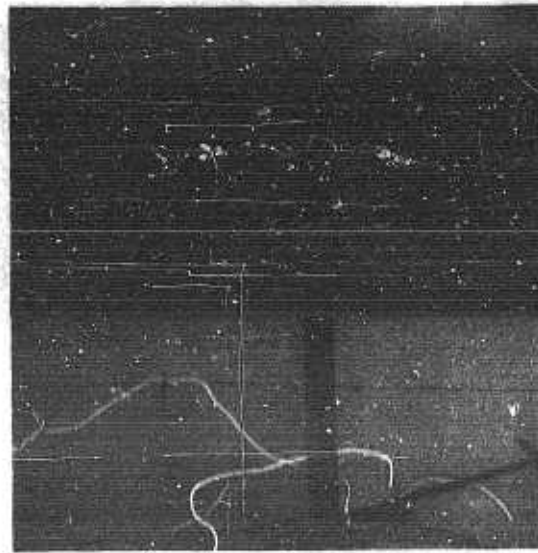
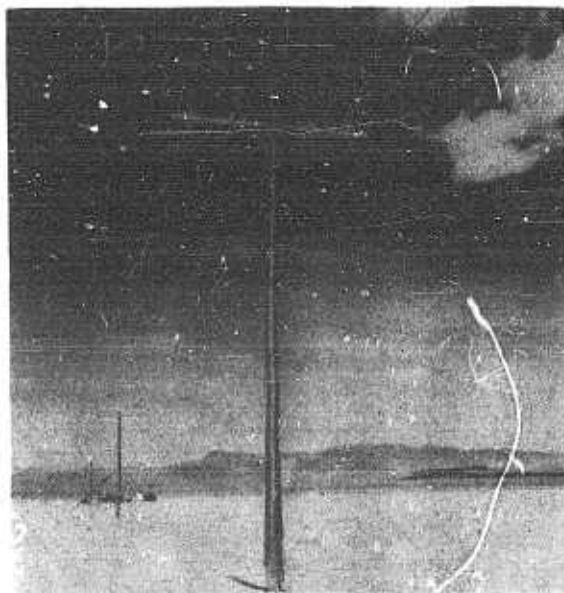
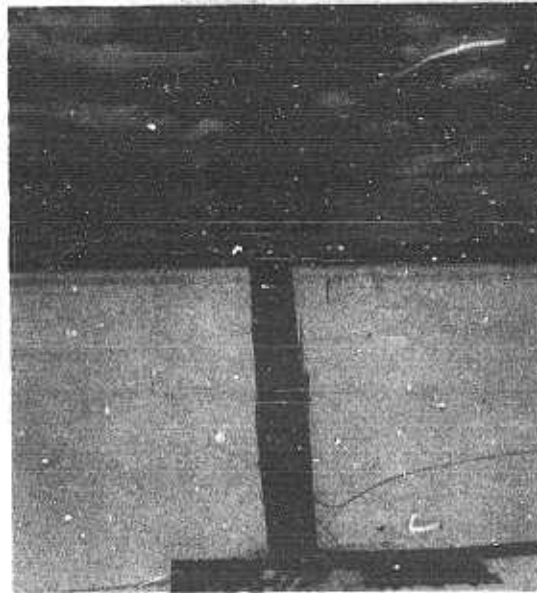
(11) CABLE TRANSFER RELAY: This relay on pole A-4 received no visible damage. A laboratory analysis indicates that this relay received no electrical or structural damage and it would have been serviceable.

Fig. 3.47 Shot 9, Test Group 30, Transverse Pole Line, Poles A-1 through A-4, A-4 in Foreground. (Top-before, Bottom-after)
Right - Close-ups of Cable Transfer Relay on Pole A-4.
(Top-before, Bottom-after) 5425 ft, 25.5 cal, 5.6 psi.

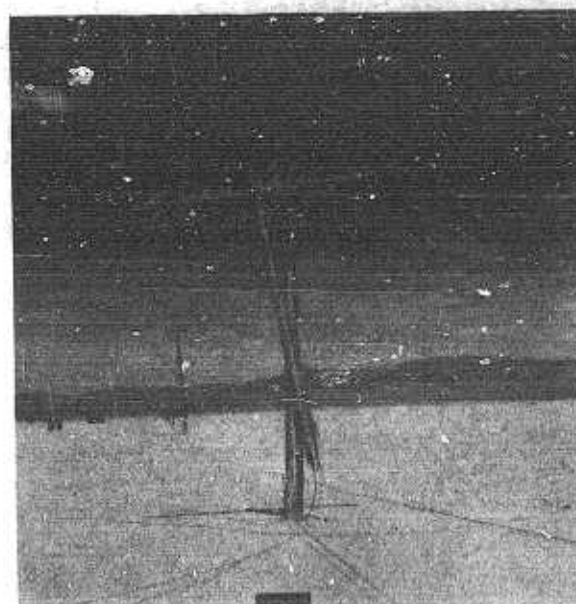
Fig. 3.48 Shot 9, Test Group 30,
Transverse Pole Line, Poles A-1
through A-6, A-6 in Foreground.
(Top-before, Bottom-after) 5425 ft,
25.5 cal, 5.6 psi.

Fig. 3.49 Shot 9, Test Group 30,
Transverse Pole Line, Poles A-1
through A-7, A-7 in Foreground.
(Top-before, Bottom-after) 5425 ft,
25.5 cal, 5.6 psi.

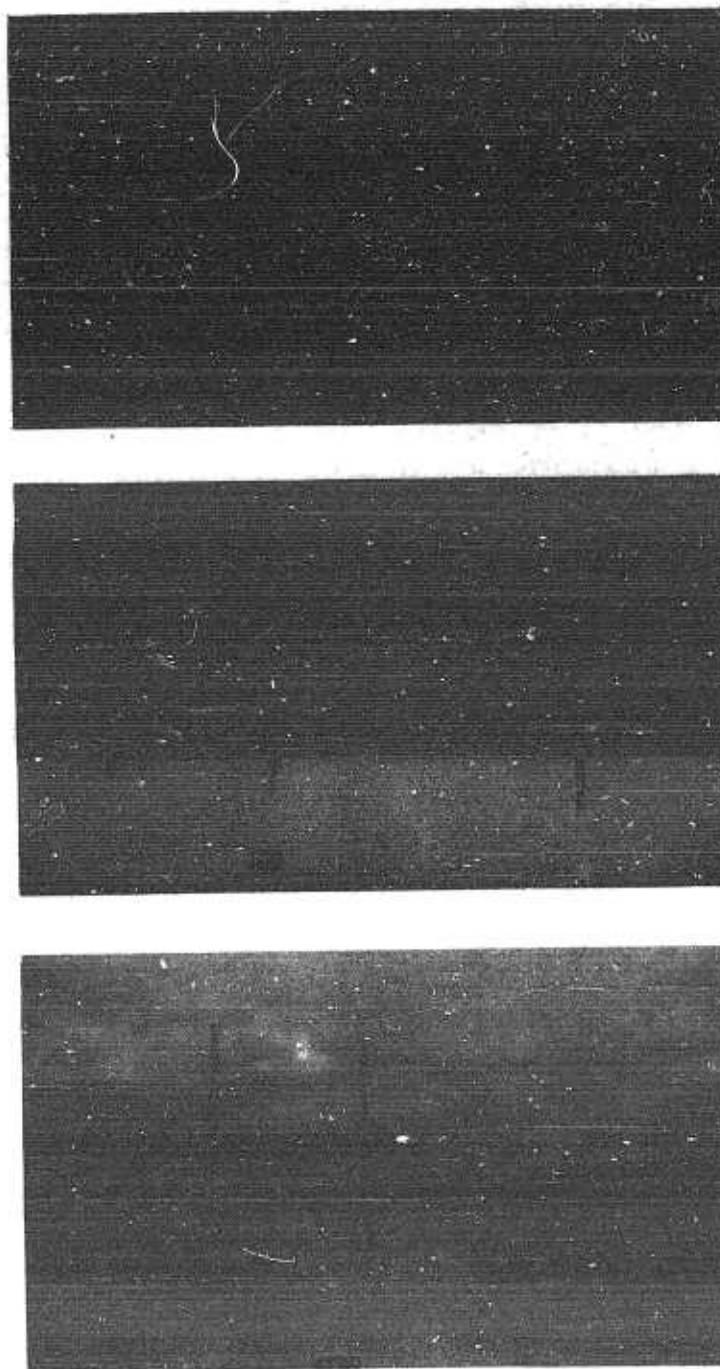
Fig. 3.62 Shots 9 and 10, Test Groups 8 and 8A, Separate Poles. (Top-before 9, Center-after 9, Bottom-after 10) (Pole on Bottom Right was Removed for other use prior to Shot 10.)
Shot 9 - 4875 ft, 30.5 cal, 6.2 psi.
Shot 10 - 4200 ft, 24 cal, 4 psi.

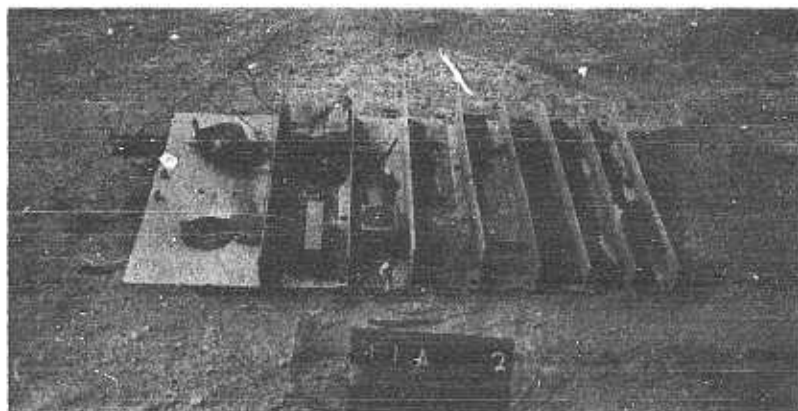
Fig. 3.71 Shots 9 and 10, Test Groups 11 and 11A, Exposure Boards, (Top-before 9, Center-after 9, Bottom-after 10) (A new Exposure Board was Positioned for Shot 10.) Shot 9 - 1825 ft 88 cal, 13.2 psi. Shot 10 - 1125 ft, over 60 cal, 32 psi.

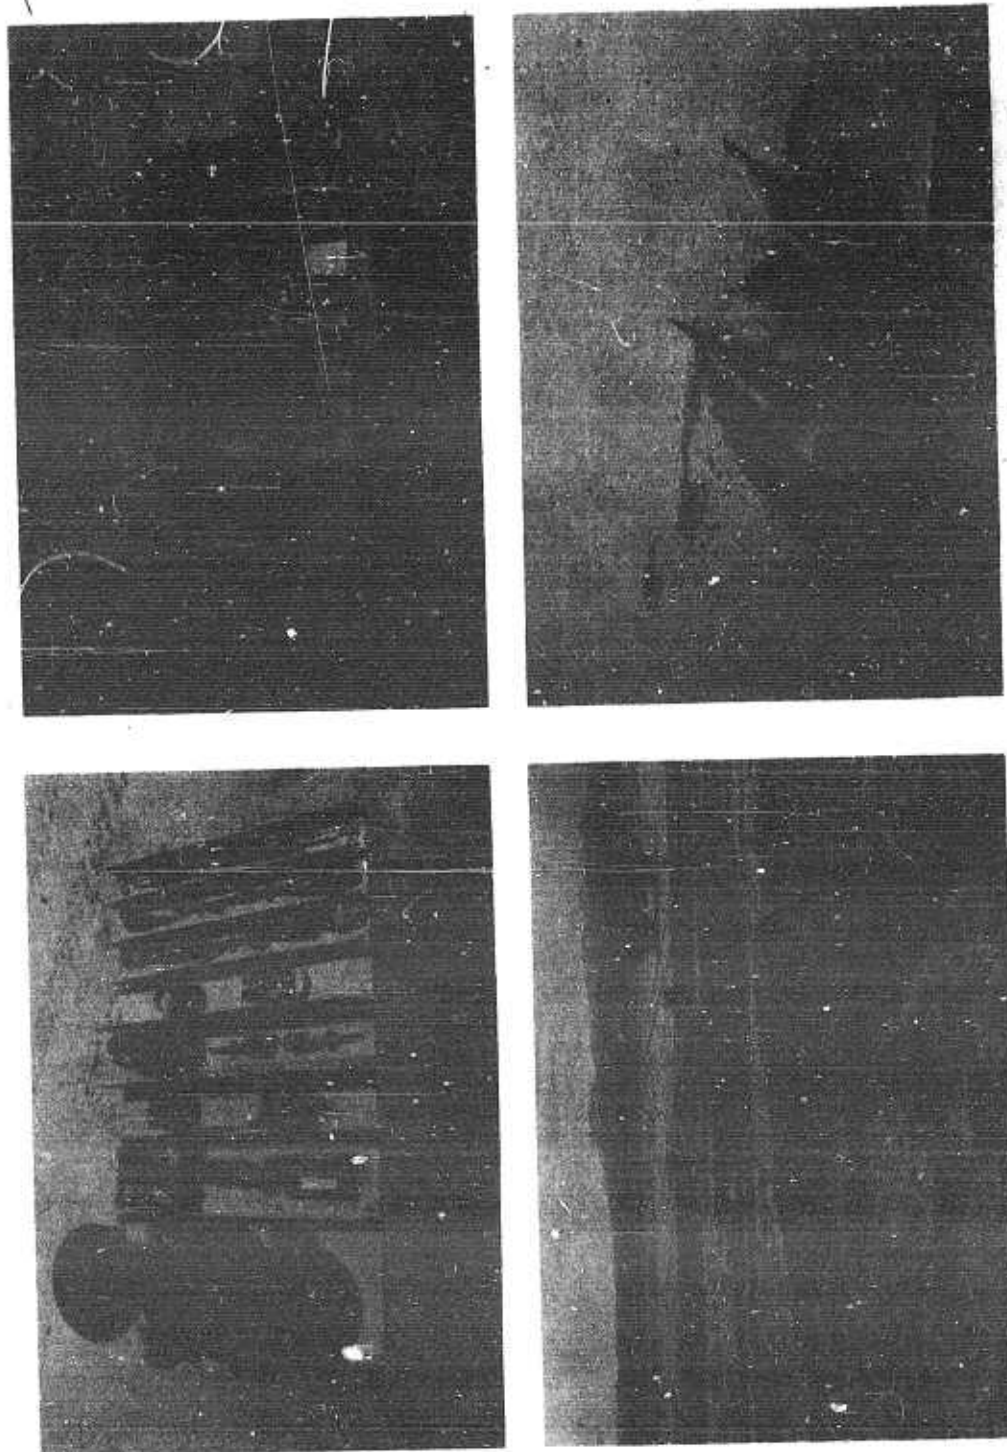
Fig. 3.73 Shots 9 and 10, Test Groups 13 and 13A, Exposure Boards. (Top left-before 9, Top right-after 9, Bottom-after 10) A New Exposure Board was Positioned for Shot 10. Bottom right-landing Position of Board 13A, 450 ft from Original Position in Shot 10. Shot 9 - 2800 ft, 62 cal, 10.8 psi. Shot 10 - 2125 ft, over 60 cal, 7 psi.

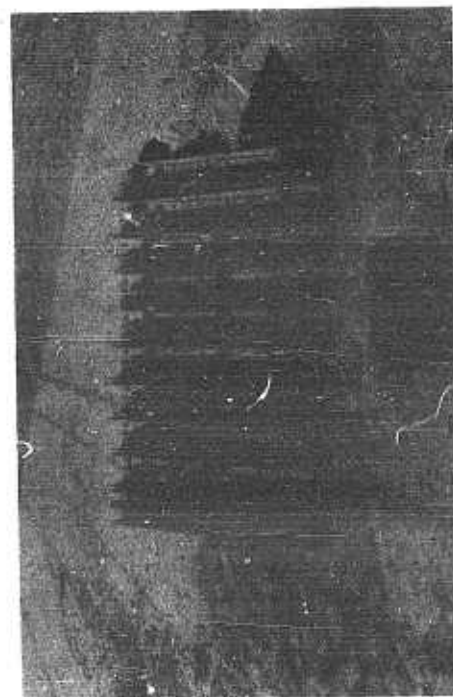
Fig. 3.74 Shot 9, Test Group 14, Exposure Boards.
(Top left-before, Bottom left-after)
3825 ft, 43.5 cal. 8.6 psi.

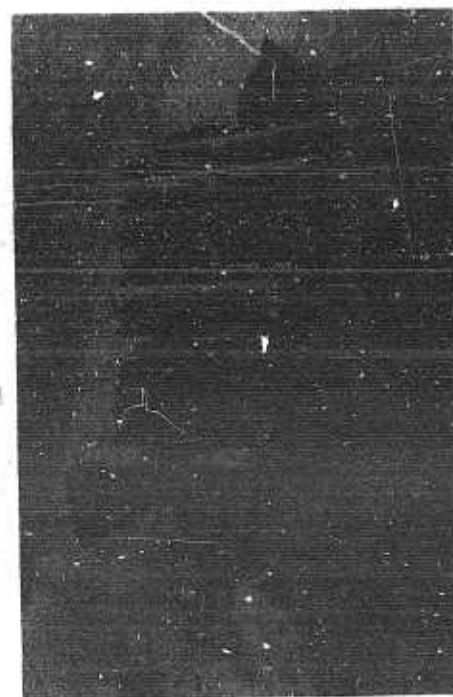
Fig. 3.75 Shot 9, Test Group 15, Exposure Board.
(Top right-before, Bottom right-after)
3825 ft, 43.5 cal, 8.6 psi.

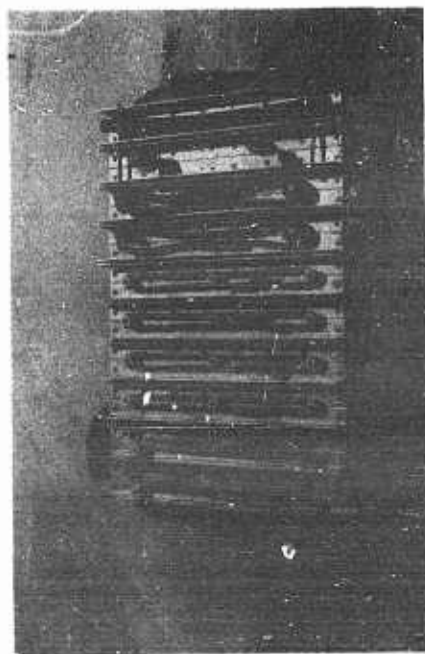
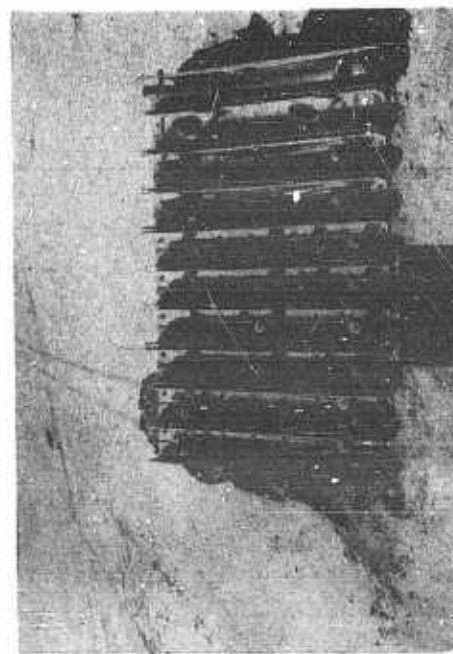
Fig. 3.76 Shot 9, Test Group 16, Exposure Board.
(Top-before, Bottom-after) NOTE: The
Positions of the Test Items on this
Exposure Board were Inadvertently
Reversed from Those of Other Exposure
Boards. 4800 ft, 30.5 cal, 6.4 psi.

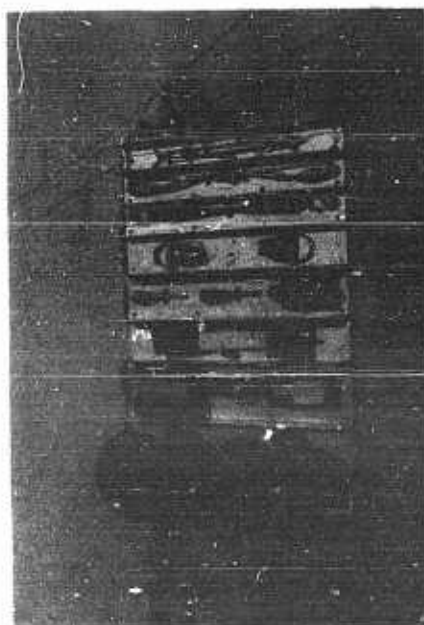
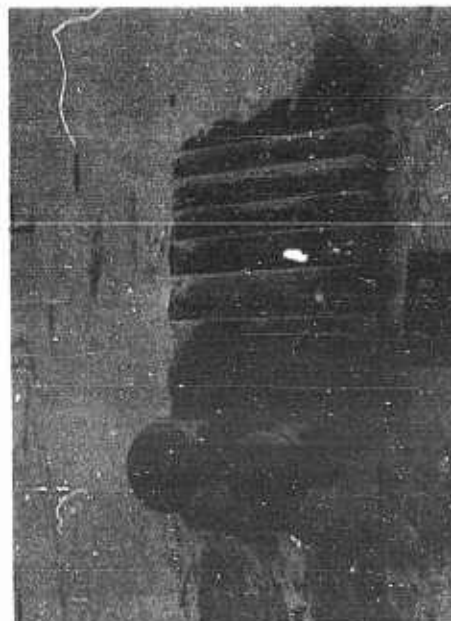
Fig. 3.77 Shot 9, Test Group 17, Exposure Board.
(Top-before, Bottom-after)
4800 ft, 30.5 cal, 6.4 psi.

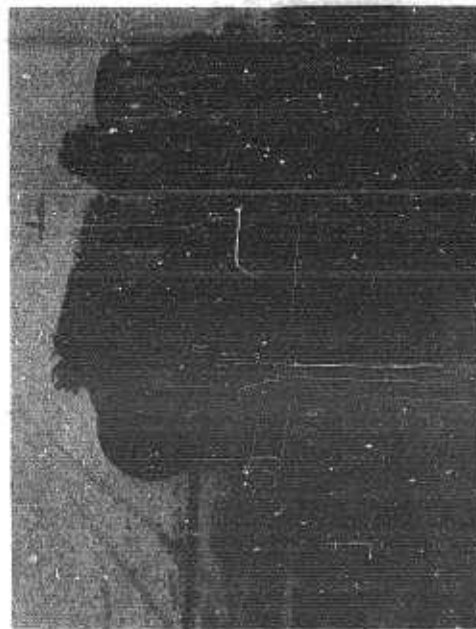
Fig. 3.78 Shot 9, Test Group 18, Exposure Board.
(Top-before, Bottom-after)
5800 ft, 23.5 cal, 7.2 psi.

Fig. 3.79 Shot 9, Test Group 19, Exposure Board.
(Top-before, Bottom-after)
5800 ft, 23.5 cal, 7.2 psi.

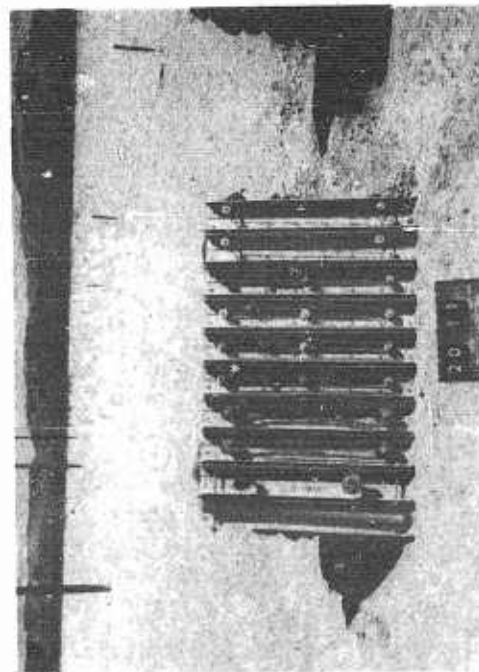
Fig. 3.80 Shot 9, Test Group 20, Exposure Board.
(Top-before, Bottom-after)
6800 ft, 16.5 cal, 4.2 psi.

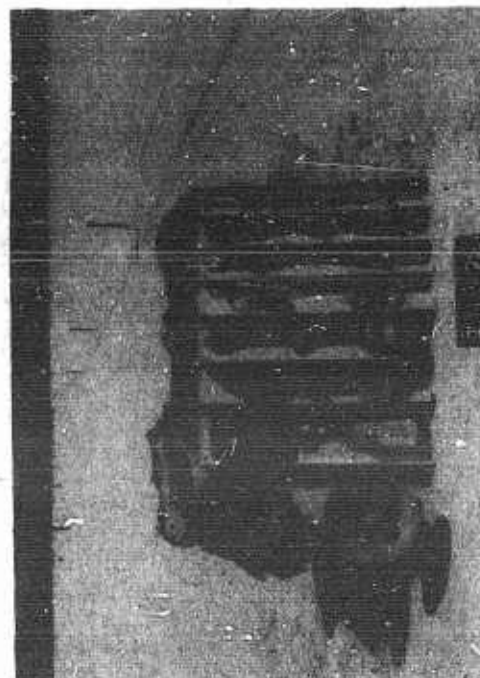
Fig. 3.81 Shot 9, Test Group 21, Exposure Board.
(Top-before, Bottom-after)
6800 ft, 16.5 cal, 4.2 psi.

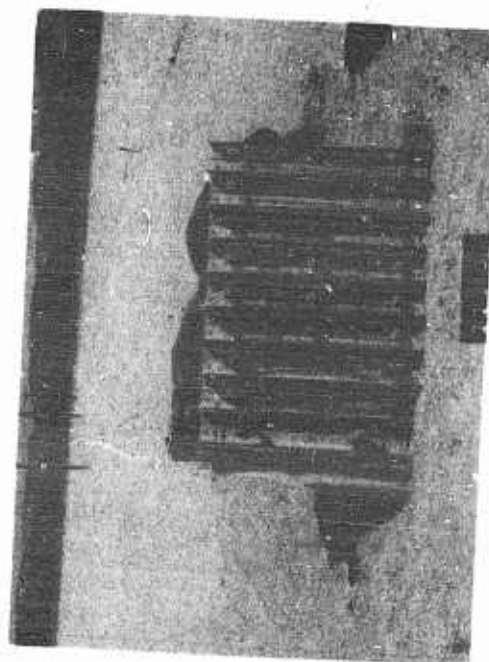
Fig. 3.82 Shot 9, Test Group 22, Exposure Board.
(Top-before, Bottom-after)
7800 ft, 10.8 cal, 3.4 psi.

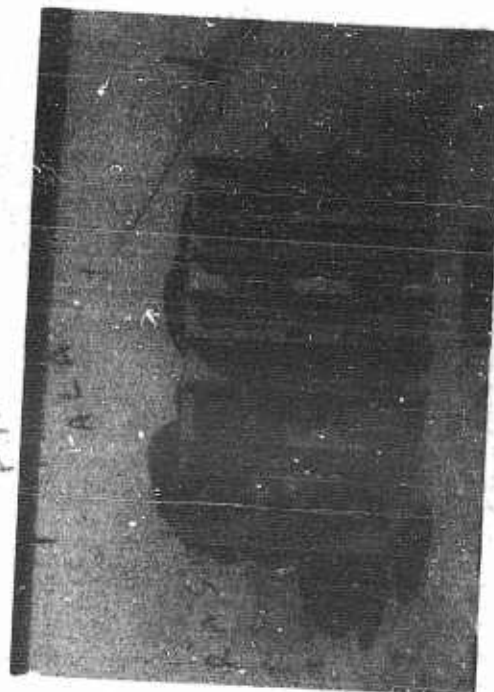
Fig. 3.83 Shot 9, Test Group 23, Exposure Board.
(Top-before, Bottom-after)
7800 ft, 10.8 cal, 3.4 psi.
